Report 1 Destruction mechanisms resulting from vibration load in PCB-mounted electronics

Toshiyuki HamanoEPSEC Environmental Test Technology Center Corp.Yoshitaka UekiBusiness Development DepartmentTakeshi NakasujiDept. of Manufacturing Science Graduate School of Engineering Osaka UniversityKozo FujimotoDept. of Manufacturing Science Graduate School of Engineering Osaka University

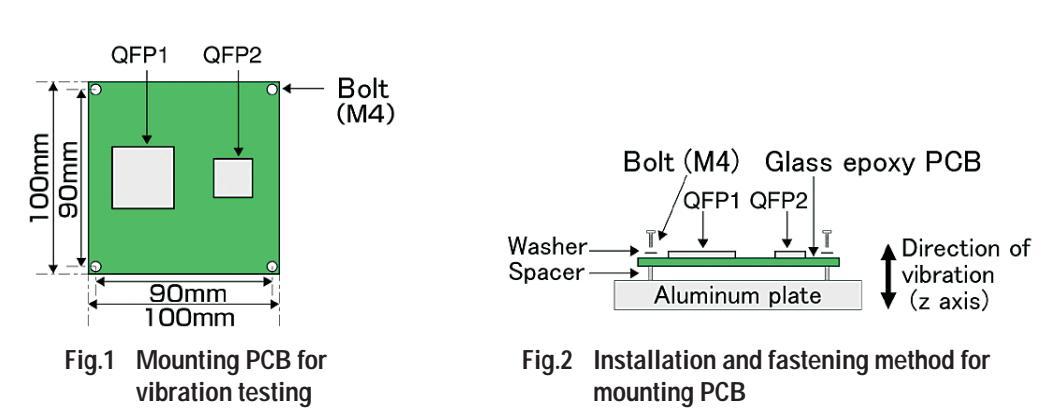
The mounting PCBs, as shown in Fig.1, were glass epoxy circuit boards (FR4 100 mm x 100 mm x 1.6 mm) containing two mounted QFP packages (240 pin, 0.5 mm pitch; and, 112 pin, 0.65 mm pitch). Sn-3.5Ag-0.75Cu solder was used for mounting. Peak mounting temperature was 240 , which is the solder material melting point plus 20 . Thermocouples were used to measure the mounting temperature at five points (3 points on the soldered sections, 1 point on the PCB surface, and 1 point on the package surface), and reflow oven temperature settings were adjusted so that the QFP mounting sections reached the prescribed temperature. The temperature profile was created with the aim of maintaining temperature at a minimum of 220 for at least 30 seconds at the areas to be heated, and maintaining the preheating section at 170 for not more than 90 seconds.

Fig.2 shows the installation and attachment of the mounting PCB shown in Fig.1 to the combined environment test system (Manufactured by Espec: EVS08-10-10, vibration force: 10 kN, max. acceleration: 909 m/s², max. displacement: 51 mmp-p, range of vibration frequency: 3 to 2000 Hz). The PCB was perforated in four places to accommodate bolts for attaching the PCB to a rigid aluminum jig that was fastened to the vibrating machine. To provide uniform fastening force, the tightening torque was standardized at 1.17 N \cdot cm (12 Kgf \cdot cm). This tightening torque was found in preliminary experiments to produce stable PCB vibration characteristics.

The direction of vibration was along the z axis. Spacers were placed between the PCB and the jig at the four fastening perforations to allow the mounting PCB to flex.

During the vibration tests, the vibration characteristics of the mounting PCB were measured using laser displacement meters (manufactured by the Keyence Corporation) with 0.1 μ m resolution to measure PCB displacement, and acceleration pickups (manufactured by Yamaichi Electronics Co., Ltd.: model 107S, sensitivity 0.039 m/s², max. acceleration: 10,000 m/s², frequency range: 1 to 20 kHz, dimensions: 4.6 x 5.8 mm, weight: 0.5g) to measure acceleration. To minimize as much as possible the affect the acceleration pickups had on the tests, devices weighing a mere 0.5 g were used.

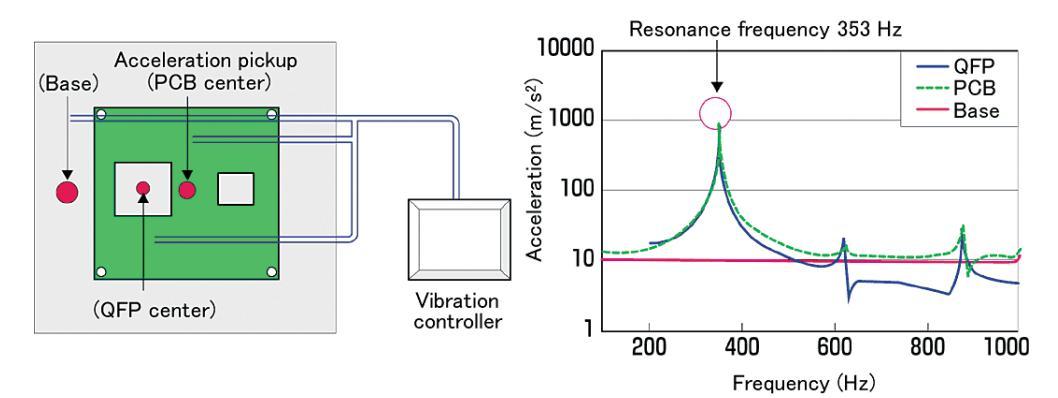
To find the resonance frequencies of the mounting PCBs used in these experiments, resonance surveys (results in Fig.3) were performed according to the resonance test conditions shown in Table 1. As these results show, the resonance frequencies detected were 353 Hz, with an acceleration of 1073 m/s², as well as resonance frequencies of 630 Hz and 890 Hz.

We selected the primary natural frequency with the greatest displacement.

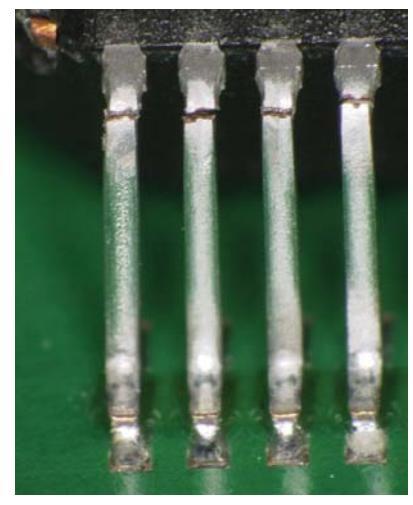
Photo 1 Ruptured leads (endurance test)

Forty-eight hours after beginning the endurance test, rupture of the QFP leads was observed. Photo 1 shows the lead rupture as seen on the high-speed camera. These results indicate that rupturing began with the first pin from the QFP corner section, then continued in succession with the second pin followed by the third pin. Despite movement being initiated by vibration applied along the z axis, the leads were observed to exhibit torsional vibration. Post-test observation confirmed that the origin of the vibration was biased toward the side surface of the QFP shown in Photo 1.

From these results, we can hypothesize that other stress is also being applied in addition to the vibration stress along the z axis applied to the QFP leads, and that differing vibration characteristics are generated on the mounting PCB.

- (1) Observation of lead rupturing with a high-speed camera showed that the QFP leads became twisted as they vibrated. Rupturing began from the first lead on the QFP corner and then continued with the neighboring leads in succession.

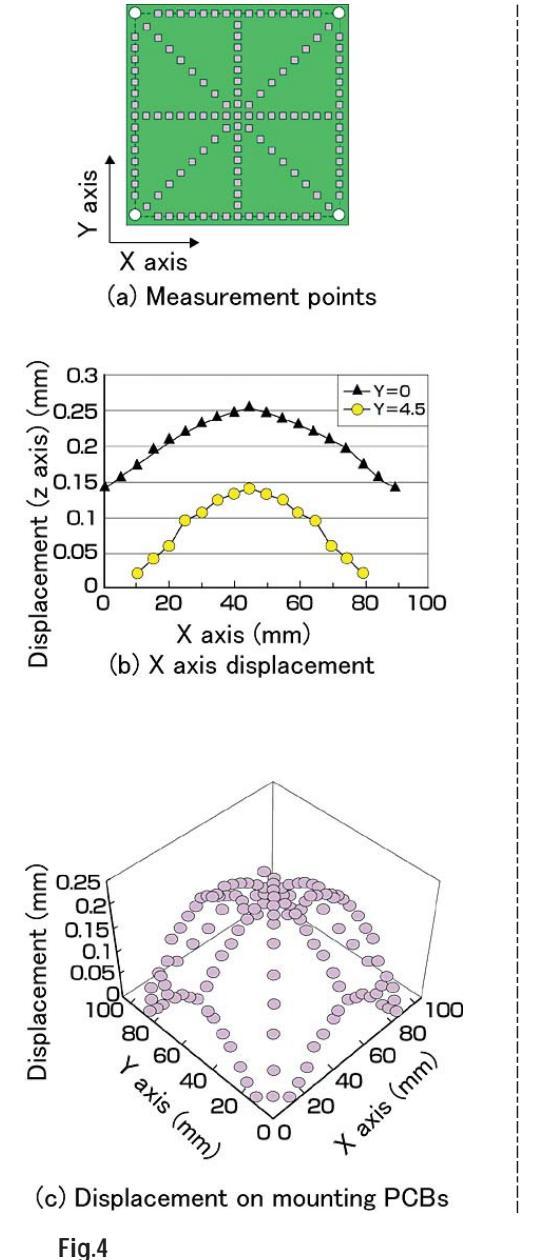
PCB displacement from resonance (without mountings)

The load on parts in the mounting PCBs used in vibration tests originates in vibration coming from the PCBs. Therefore, in order to grasp the measurement functions of the acceleration pickups used in these measurements and to identify the vibration of the mounting PCBs, we measured displacement motion for both PCBs with no parts attached and PCBs with two QFP packages attached. Fig.4 and 5 show the results.

These measurements, shown in Fig.4 (a) and Fig.5 (a), were taken at 5 mm intervals on the PCBs. These results show that when acceleration vibration of 9.8 m/s^2 is applied, at that resonance frequency PCB displacement is 0.25 mm at the center of the PCB.

Also, the displacement at the y = 0 point in both Fig.4 (b) and Fig.5 (b) indicates that the restraint from mounting parts results in smaller displacement measurements.

- (2) The displacement accompanying PCB vibration was greater from the fastening points toward the center of the PCB, with curvature occurring between fastening points. We confirmed that restraint due to mounting parts reduced the vibration displacement of the PCB.

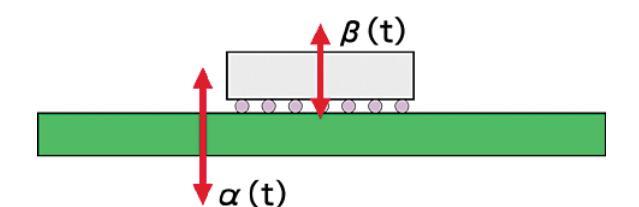
Fig.6 Acceleration of PCB and parts during vibration tests

PCB-mounted QFPs are designed so that the packages are linked to the PCB by leads that contain a certain spring constant, and vibration is transmitted through these springs. As a result, there is a variation between the vibration acceleration of the parts and the vibration acceleration of the PCB, as Fig.6 shows.

(t) = the vibration acceleration of the PCB, (t) = the vibration acceleration of the parts, m_1 = the mass of the PCB, m_2 = the mass of the parts, and F = the force acting on the leads serving as linkage. Then: $F = m_1$ (t) - m_2 (t) $= m_1$ max sin(w t+ 1)- m_2 max sin(w t+ 2) (1).

This indicates that the differences in acceleration and phase have a major impact on the force acting on the leads that link the parts to the PCB.

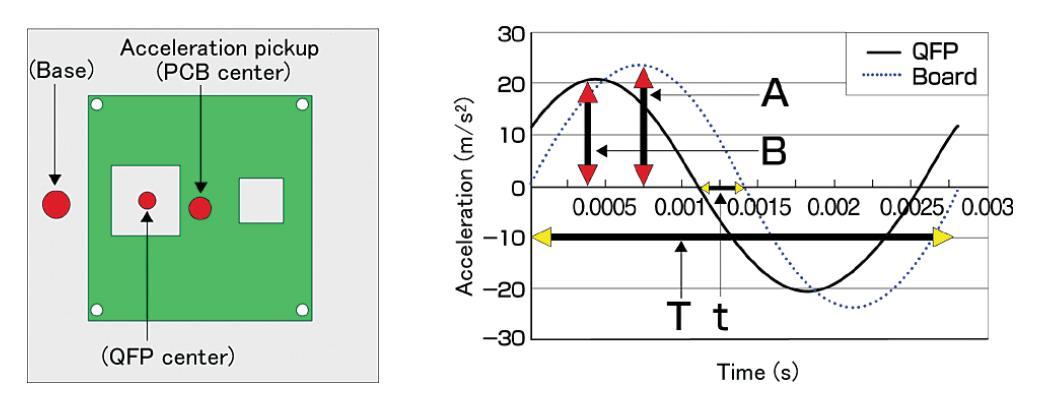
Fig.7 shows the differences in acceleration measurements at the center of the PCB and at the center of the QFP. We collected data on (1) vibration applied to the PCBs as well as actual vibration on the PCBs, and (2) vibration applied to the QFPs as well as actual vibration on the QFPs. Taking the applied vibration, which was common to both, as standard, we graphed the vibration occurring on the PCBs and on the QFPs.

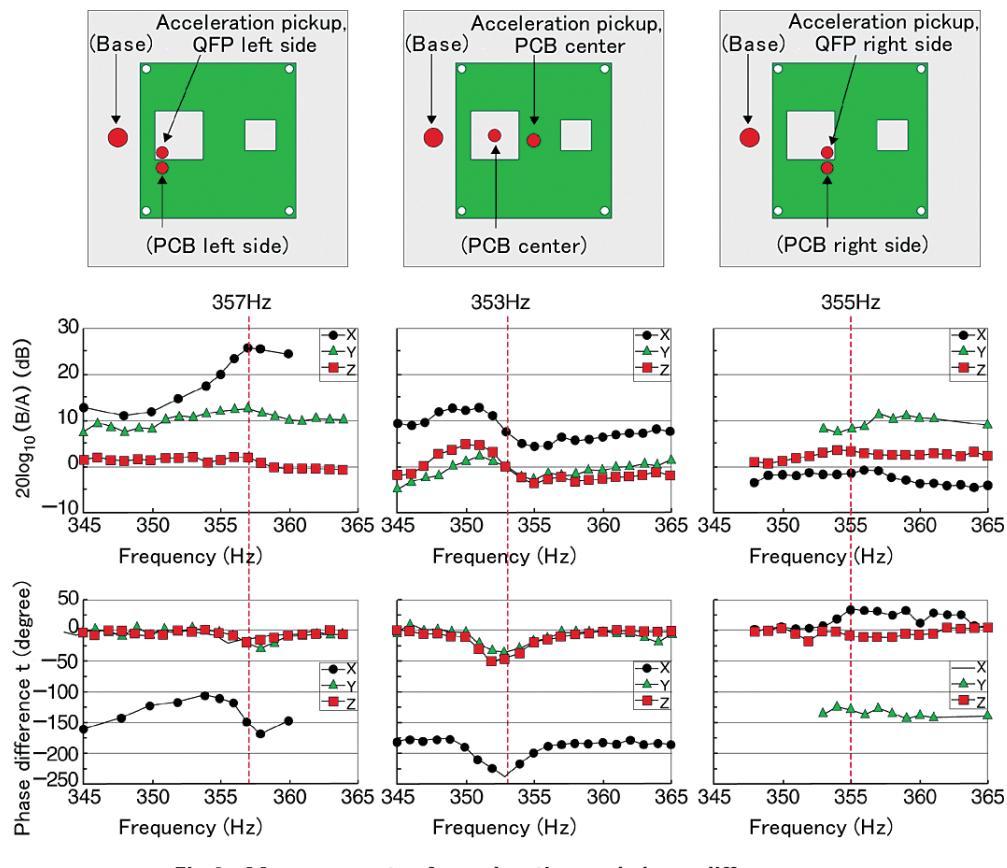
Fig.8 Measurements of acceleration and phase differences between PCB and QFP

To confirm the amount of phase and acceleration difference resulting from the position on the PCB, we searched in close proximity to the QFP for phase difference t and acceleration difference (20 \log_{10} B/A) between the QFP and the PCB. Fig.8 shows the results. The vibration was applied on the z axis in close proximity to the resonance frequency. The acceleration measurements at this time included measurements for each of the x, y, and z axes, with results calculated for each. The lines shown in the graphs represent the maximum acceleration (displacement) frequencies reached (resonance frequency) for each location, and so the nine graphs in Fig.9 (a-1) to (c-3) show the acceleration variation for the frequencies on each axis (x, y, and z). From these results, we find the variation in acceleration differences between the PCB and the QFP shown in the final three graphs, Fig.9 (a-4, b-4, and c-4).

As can be seen from Fig.8, a certain amount of difference exists, and the phase difference becomes greater in closer proximity to the resonance frequency. Also, depending on the location, the phase difference is greater on the different axes of vibration: to the right of the QFP (near the center of the PCB) for the vibration on the y axis the gain difference is 10 dB and the phase difference is -150 °, while to the left of the QFP (near the edge of the PCB) for the vibration on the x axis the gain difference is 28 dB and the phase difference is -150 °.

- (3) We confirmed that in proximity to the resonance frequency the greatest acceleration gain difference and phase difference on the parts (QFP) and on the PCB occurred in close proximity to the linkage points of the parts.

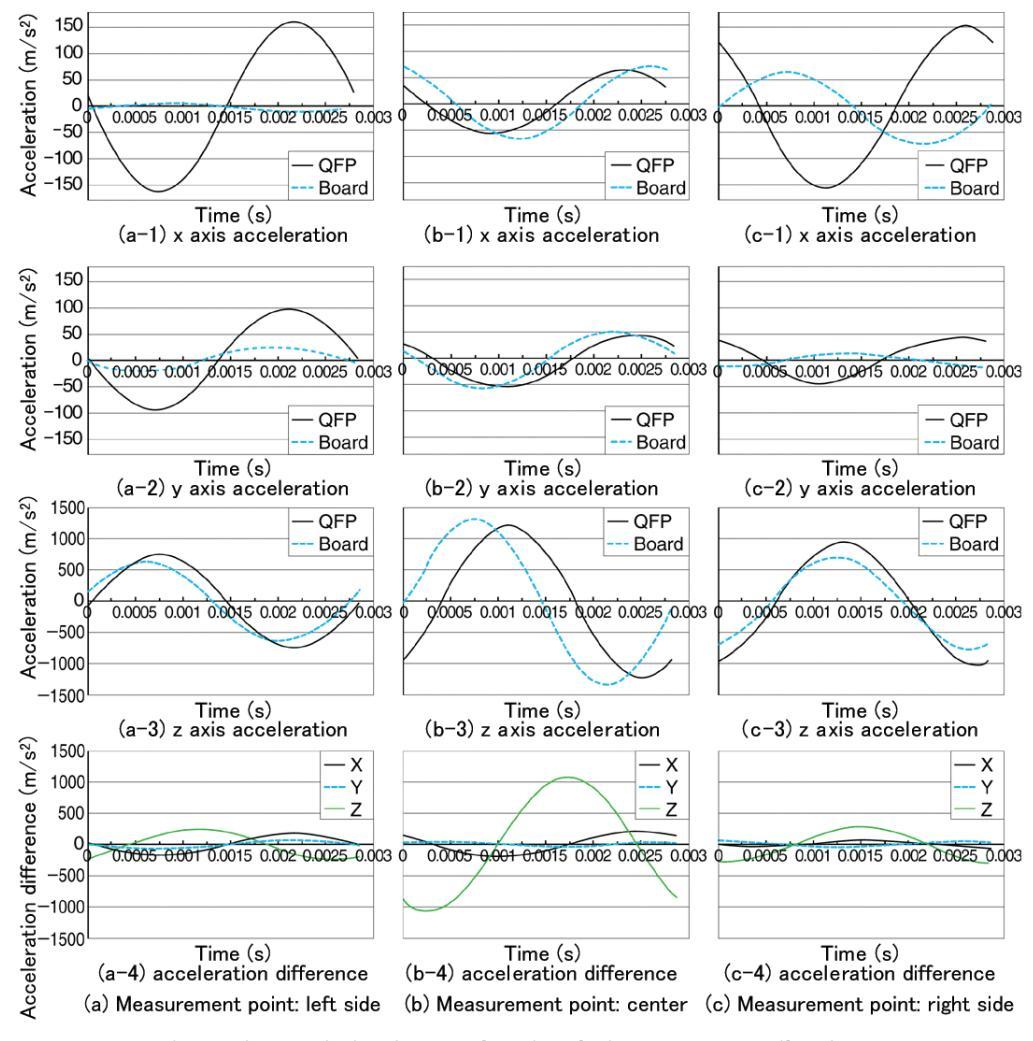
The greatest acceleration occurs in the vibration along the z axis. This can be seen from the time variation of the acceleration in the resonance frequencies along with the time variation of the acceleration difference between the PCB and the QFP as shown in Fig.9. The acceleration along the x and y axes is less than one tenth that of the z axis, but we find that the acceleration difference is greater in close proximity to the leads at (a) and (c). In particular, the QFP location near the edge of the PCB shown in Fig.9 (a) exhibits an acceleration difference on the x axis of 200 m/s², which is greater than other locations. Observation with the high speed camera confirmed that this phenomenon corresponded to torsional vibration and also to rupture onset locations. In the results shown in (b) for measurements taken at the center of the PCB and at the center of the QFP, uniform acceleration was seen on all three axes, and no major difference was observed between the acceleration on the PCB and the QFP.

- (4) Little variation was seen in the scale of individual vibrations on the QFP mounted section, but increased PCB and QFP acceleration and phase difference were seen in proximity to the leads near the edge of the PCB. Also, the cross-directional x axis acceleration difference increased in response to the z axis load, causing twisting to occur. This torsion is believed to have caused the initial rupturing.
